**2017 Data Report
for
Birch Lake, Cass County**

Site ID: 140187

Birch Lake, Cass County 2017 CLMP Results

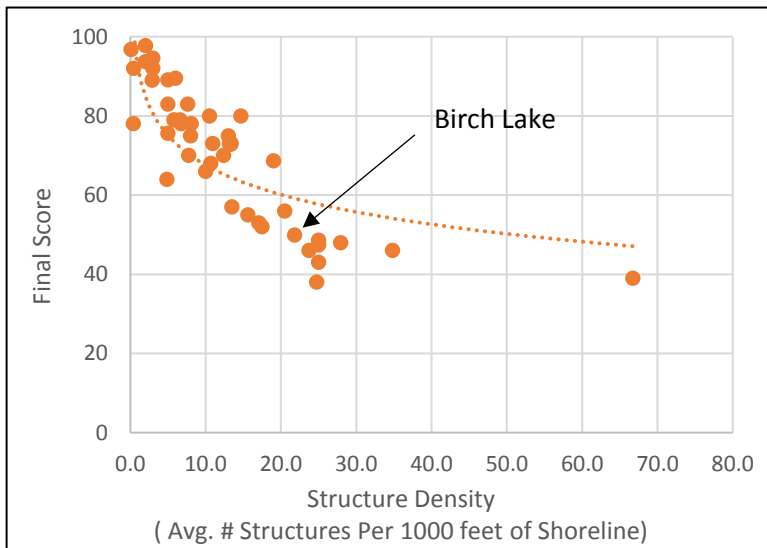
How does your lake compare to others in the program?

Birch Lake:	
Number of Sections:	16
Number of Structures:	349
Structure Density:	21.8
Final Score:	49.9

All 43 Participating Lakes from 2015-2017:	
Avg. Number of Sections:	16.3
Avg. Number of Structures:	248.5
Avg. Structure Density:	15.2
Avg. Final Score:	70.5

There is a very tight relationship between Final Score and Structure Density. It will be interesting to see if and how this changes as more lakes go through this scoring process.

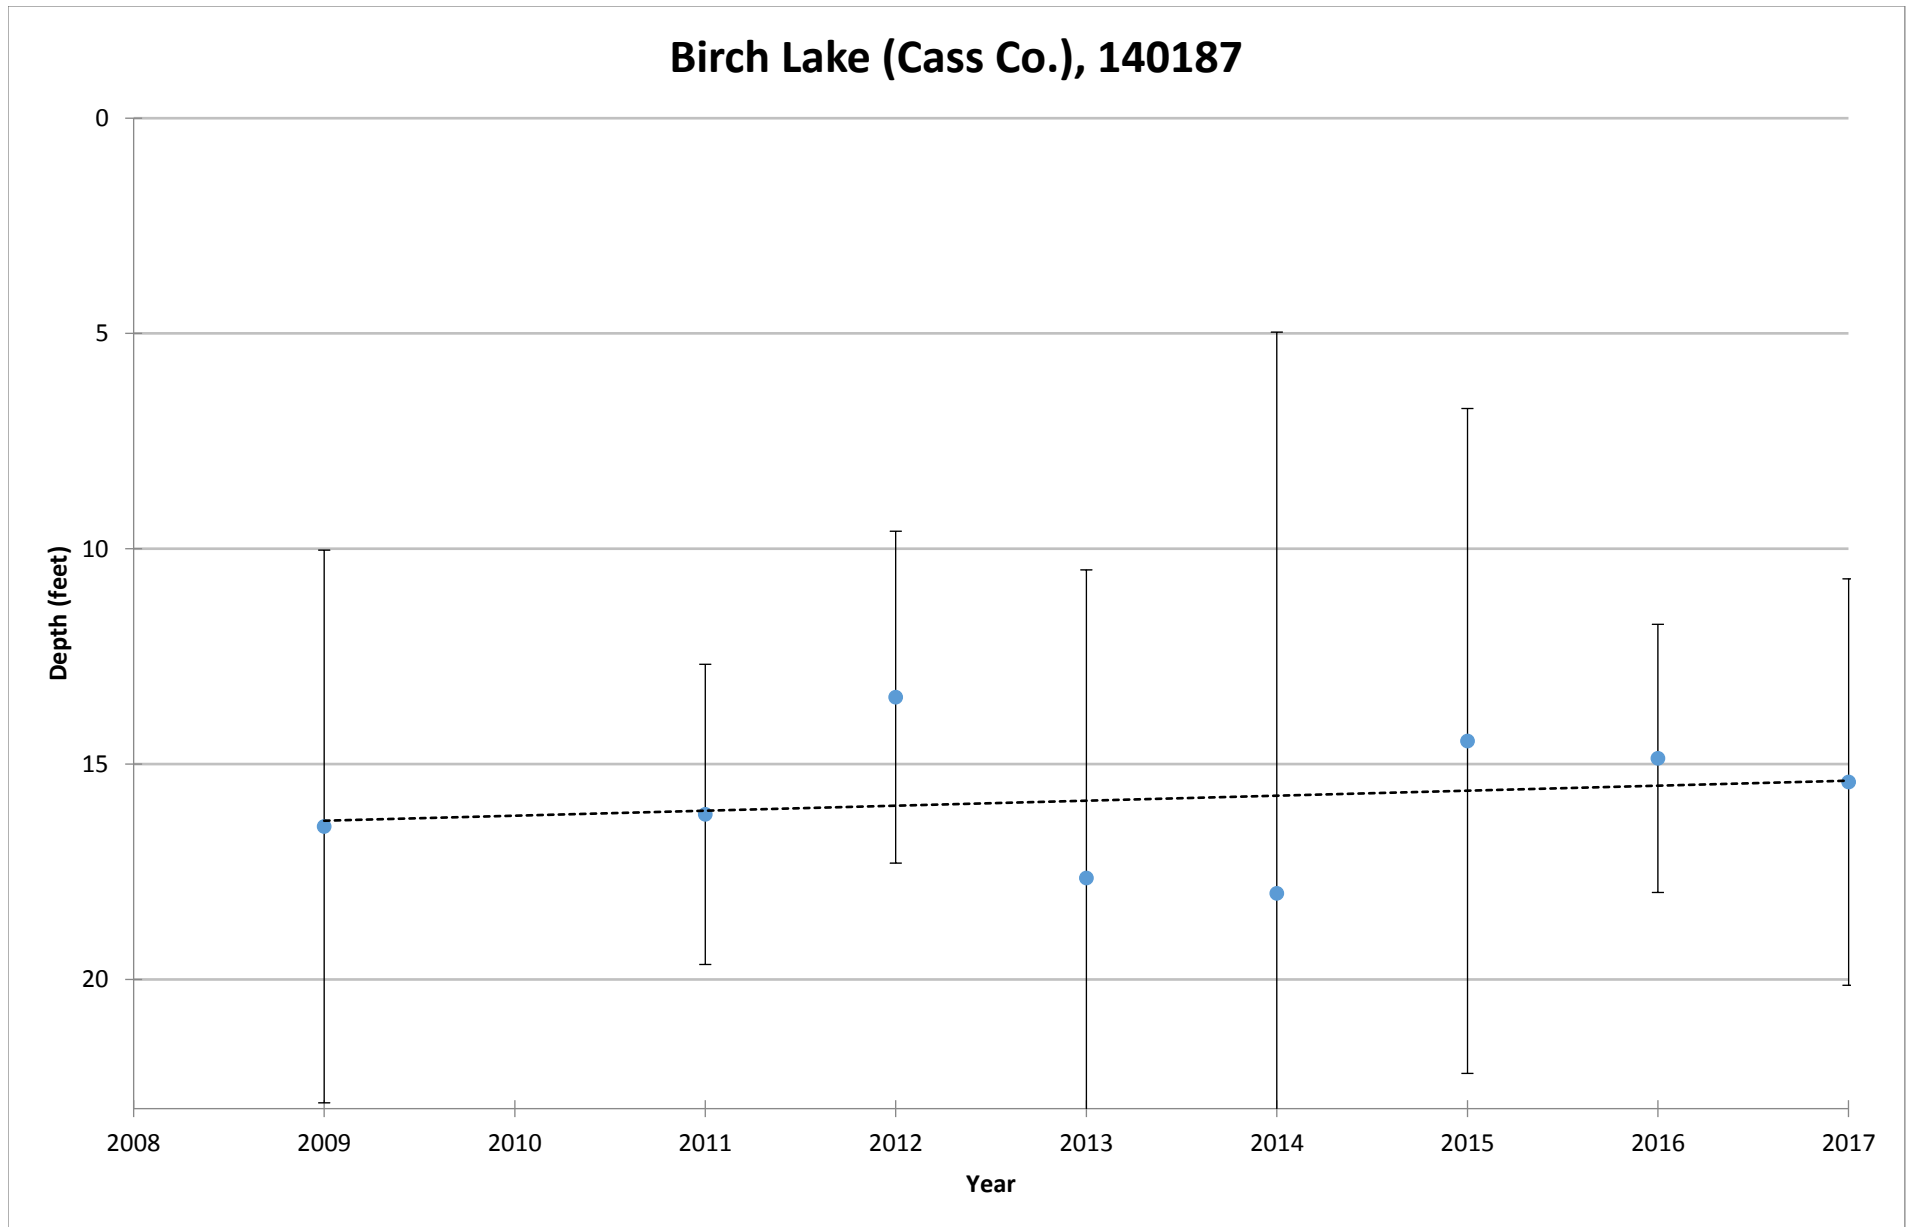
COOPERATIVE LAKES MONITORING PROGRAM
SUMMER MEAN TRANSPARENCY

Birch Lake (Cass Co.), 140187

Vertical bars indicate standard deviation

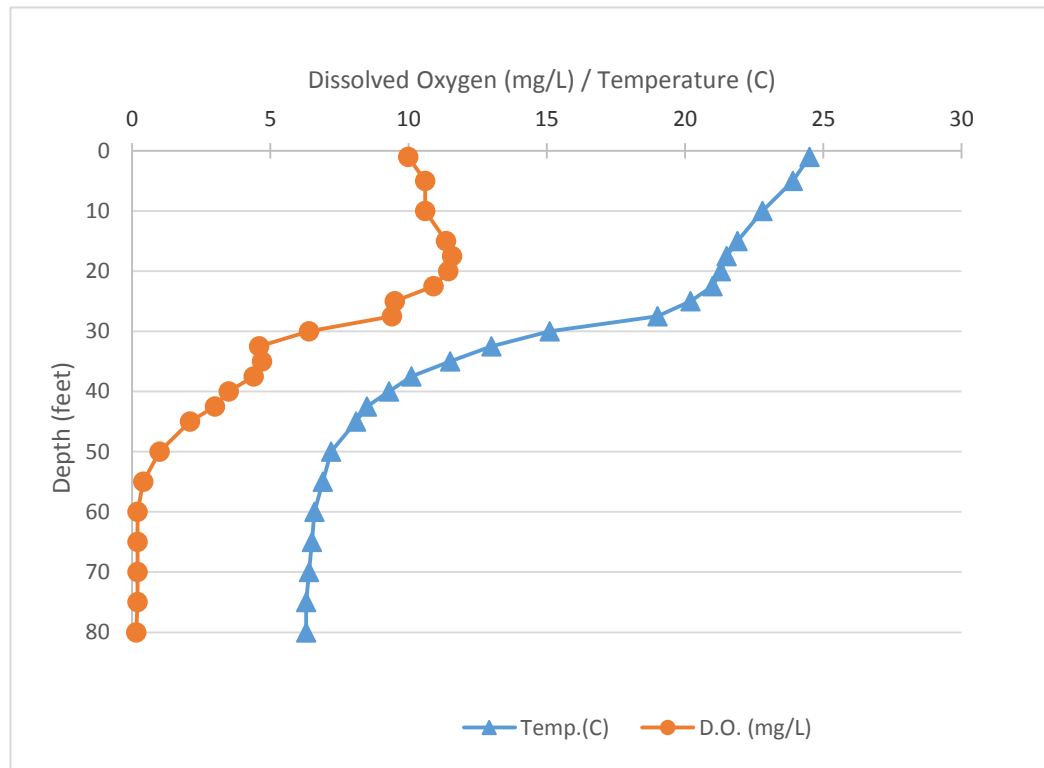
Dissolved Oxygen and Temperature Profile

Name: Birch Lake
 County: Cass
 Site ID: 140187
 Date: 9/22/2017

Depth (ft)	Temp.(C)	D.O. (mg/L)
1	24.5	9.99
5	23.9	10.6
10	22.8	10.6
15	21.9	11.35
17.5	21.5	11.58
20	21.3	11.44
22.5	21	10.9
25	20.2	9.5
27.5	19	9.4
30	15.1	6.4
32.5	13	4.6
35	11.5	4.7
37.5	10.1	4.4
40	9.3	3.5
42.5	8.5	3
45	8.1	2.1
50	7.2	1
55	6.9	0.4
60	6.6	0.2
65	6.5	0.2
70	6.4	0.2
75	6.3	0.2
80	6.3	0.15
